FATIGUE BEHAVIOR OF STEEL BEAMS WITH WELDED DETAILS

GARY ROBERT BARDELL

A THESIS

DEPARTMENT OF CIVIL ENGINEERING

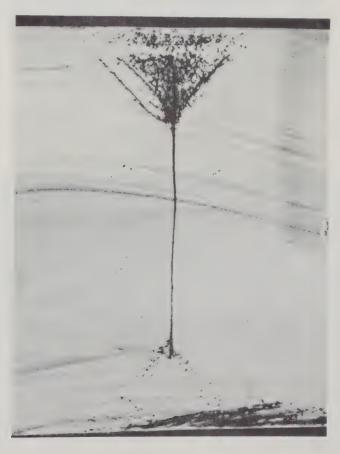
towards the web. Figure 4.2 illustrates this type of failure (Fig. 4.7 shows the type of notch which initiates this form of cracking). Failure of the beam occurred prior to these cracks reaching the web. Thus, this type of crack grew in only one direction.

FIGURE 4.2 CRACK INITIATING AT NOTCH IN FLANGE TIP

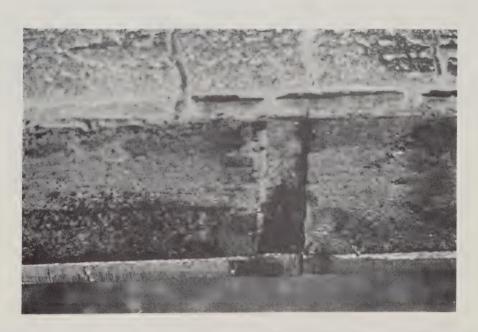
There were no noticeable flaws in the groove welds of those beams in which the cracks initiated at the flange tips. The cracks generally started at the toe of the groove weld in locations where the curvature at the toe of the reinforcement was the greatest. This was especially noticeable at those locations where the transition in thickness to the reinforcement was abrupt. These cracks propagated from the flange tip toward the web, along the toe of the reinforcement. Failure of the beam generally occurred when the fatigue crack reached the vicinity of the web, that is, with approximately 50% of the tension flange cracked. Figure 4.3 shows a failure crack of this type.

FIGURE 4.3 CRACK INITIATING AT TOE OF GROOVE WELD REINFORCEMENT

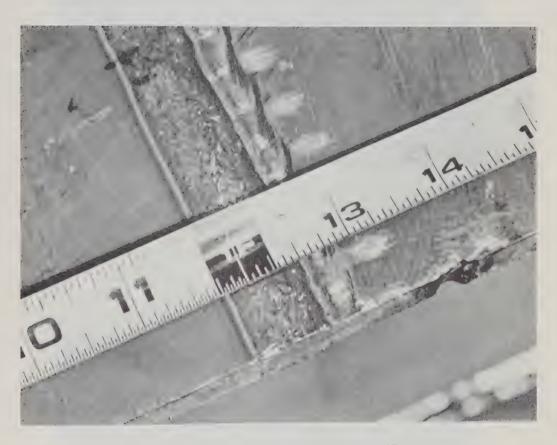
FIGURE 4.8 FLANGE-TO-WEB FILLET WELD FLAW

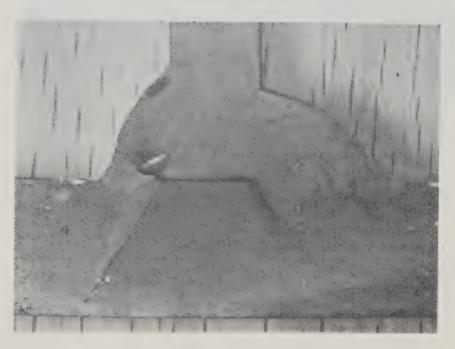
FIGURE 4.9 FILLET WELD FLAW

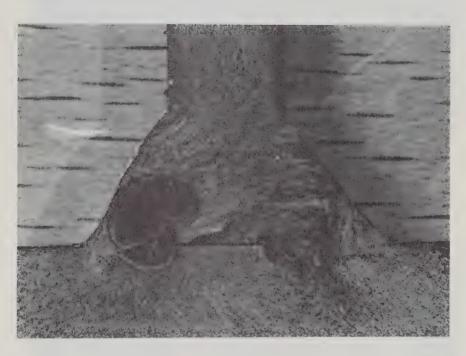
FIGURE 4.10 FILLET WELD FLAW AND FATIGUE CRACK

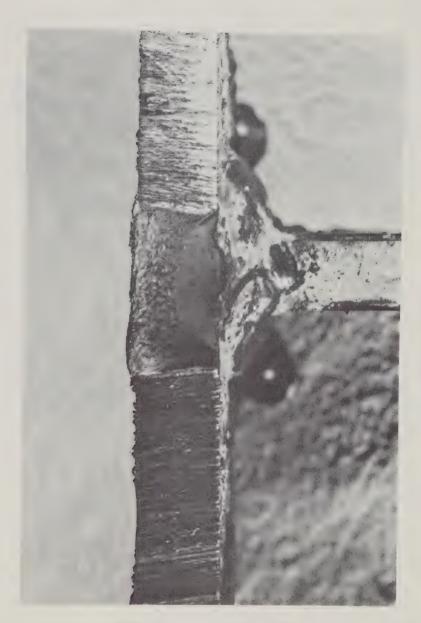
FIGURE 4.16 FATIGUE CRACK IN BEAM WEB AT TOE OF GUSSET PLATE FILLET WELD (X3.25)

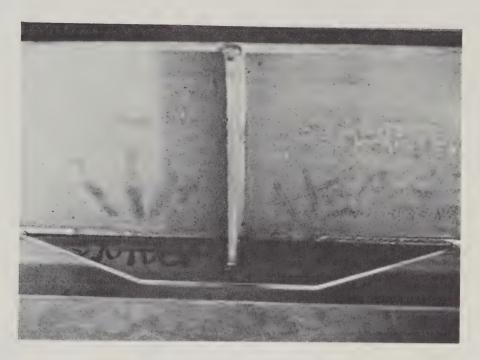
It appears that the notch-producing detail at the toe of the fillet weld together with the stress in the beam web at this point govern the fatigue life. The defects at the weld toe, such as an undercut or a slag inclusion, will be essentially the same with both types of details. Thus, in order to improve the fatigue strength with this tapered attachment, it would probably be necessary to grind the fillet weld in order to conform with the tapered slope and also to remove any notch-producing defects in this region.

FIGURE B.3 FATIGUE CRACK AT TOE OF ATTACHMENT FILLET WELD
